# **Watershed Assessment of Tryon Creek of Oregon**

This document was written in cooperation with the Tryon Creek Watershed Council by Danielle Goodrich as a master's project for the Professional Science Master of Environmental Science and Management degree at Portland State University, Oregon.

**December 17, 2019**

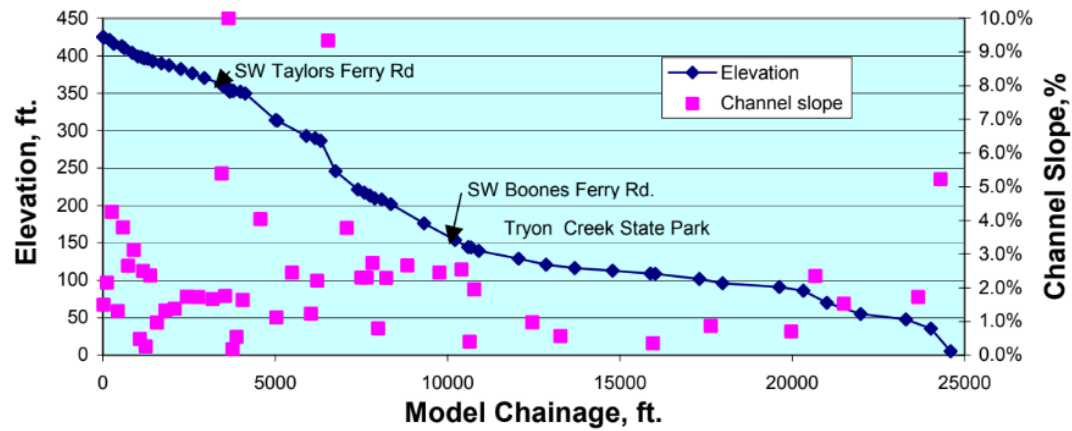
Figure 3.2A Model stream profile and channel slopes for Tryon Creek (Source: City of Portland).

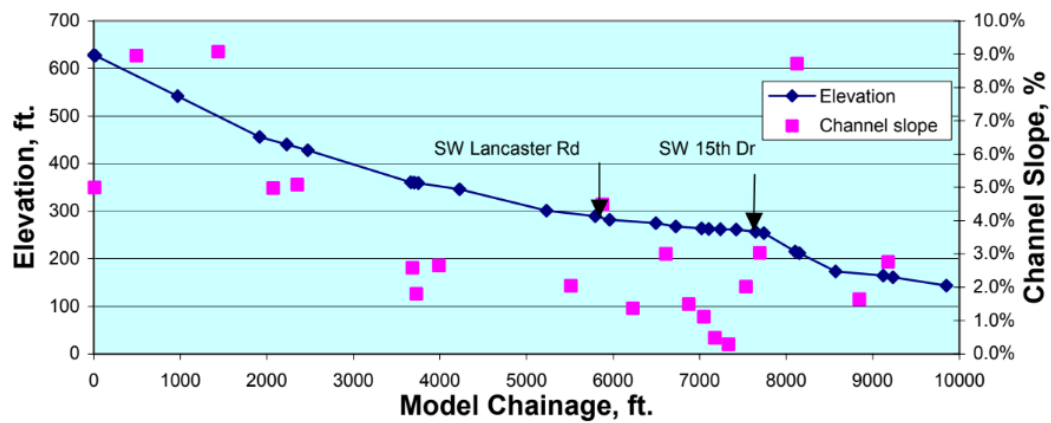
Figure 3.2B Model stream profile and channel slopes for Arnold Creek (Source: City of Portland).

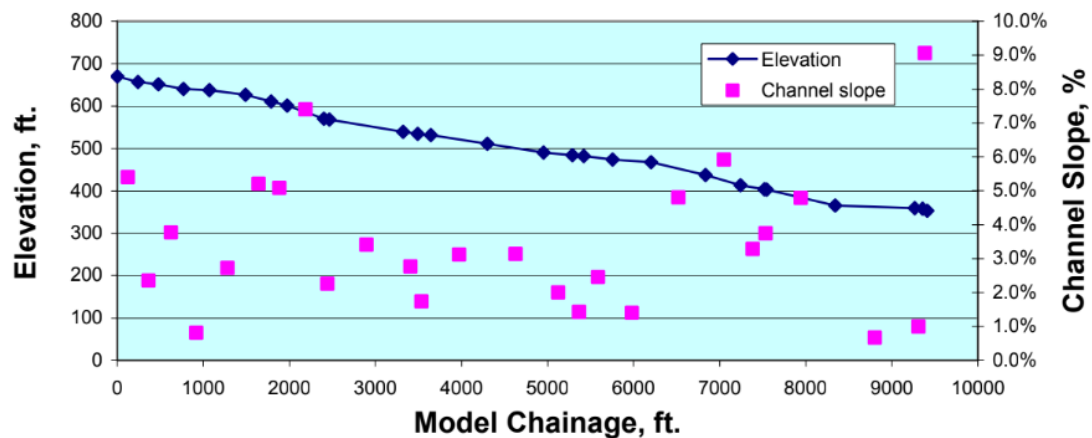
Figure 3.2C Model stream profile and channel slopes for Falling Creek (Source: City of Portland).

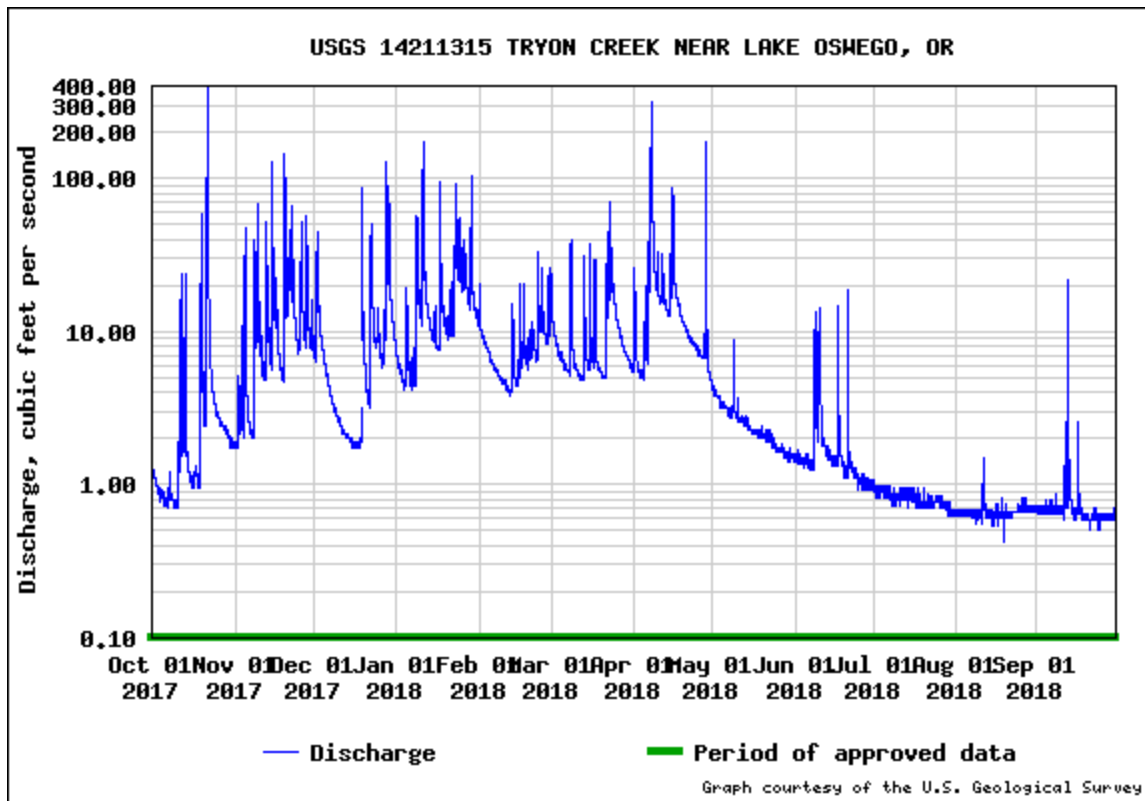
Figure 4.1 Recorded daily discharge for the year of 2018 (Source: United States Geological Survey).

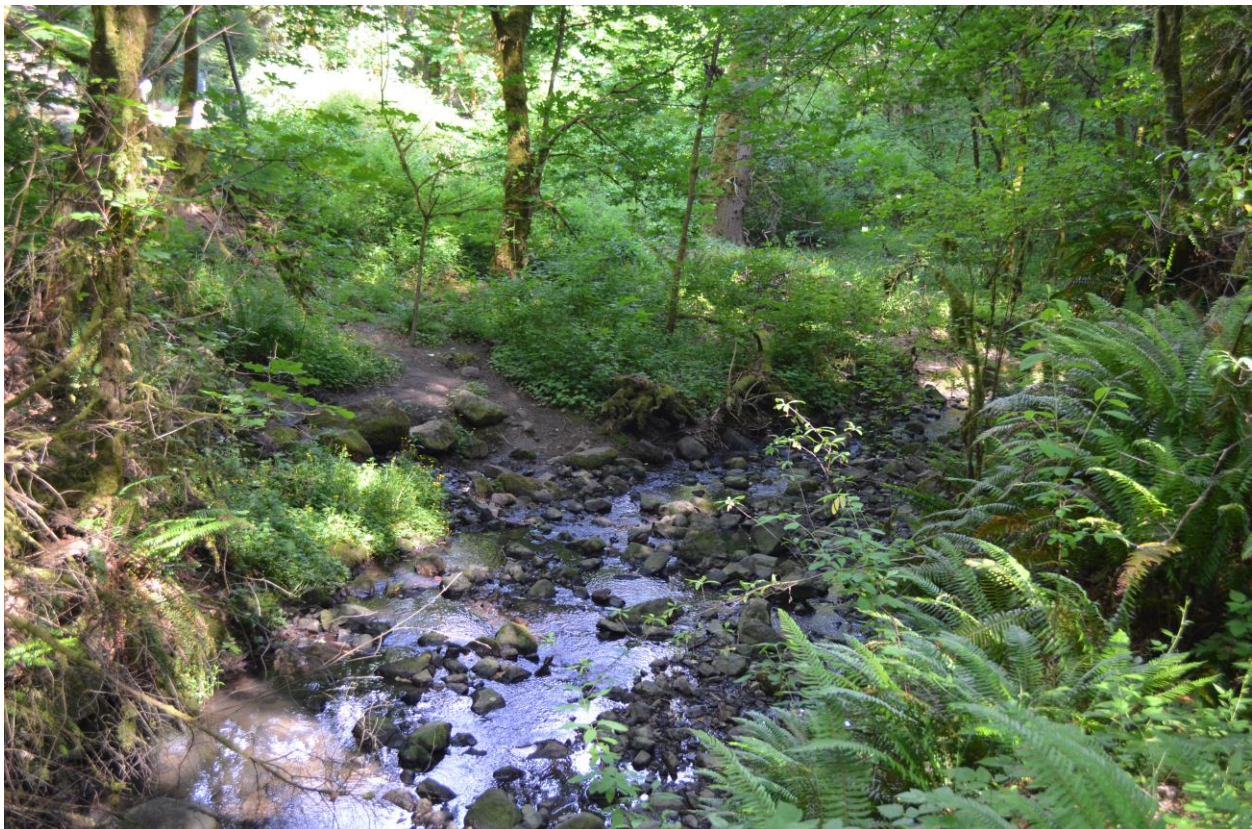
Figure 5.1 displays an image of the riparian environment of Marshall Park, which is upstream of the Tryon Creek State Natural Area. This image demonstrates the development of young and mid-growth trees and a verdant understory of ferns and mixed shrubs. Within the Tryon Creek State Natural Area, the dominant vegetation class is Fo4, which is comprised of big leaf maple (*Acer macrophyllum*), red alder (*Alnus rubra*), western red cedar (*Thuja plicata*), mixed shrub, English ivy (*Hedera helix*), and sword fern (*Polystichum munitum*) (table 5.2). This is indicative of a deciduous and mixed conifer forest ecology, rather than the historic old growth forest. The most common occurring trees throughout the park were big leaf maple, red alder, Douglas fir (*Pseudotsuga menziesii*), and young to mid-age western red cedar. While the understory was dominated by mixed shrubs, Oregon grape (*Mahonia aquifolium*), ferns, and English ivy. Exotic and noxious weeds were abundant throughout the park with English ivy identified as the most prolific.

Figure 5.1 Photograph of riparian environment of Tryon Creek within Marshall Park (Source: Barton, A.).

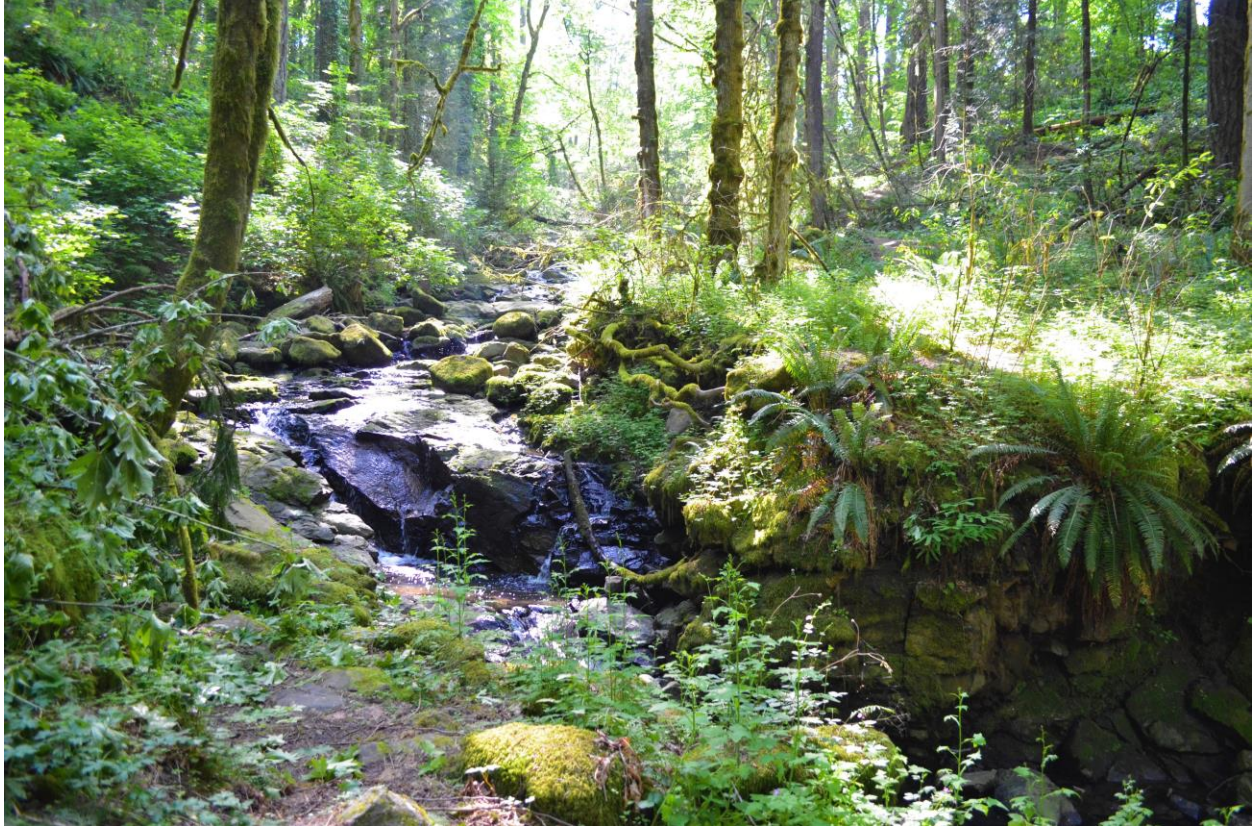
Tryon Creek State Natural Area and the surrounding forest are characterized by a steep ravine landscape. Basalt flows have traveled throughout the watershed resulting in a landscape composed of approximately 60 to 75 percent of the slopes exceeding a 30 percent grade (City of Portland, 2009). Sediments are easily transported by the waters that fill the steep and confined channels of Tryon Creek. Historic flows are a major source of natural sediments that impact the watershed. The bedrock resulting from the Columbia River Basalt Group (CRBG) can be seen exposed along various portions of the upper channel of Tryon Creek and the lower portion of the Tryon Creek State Natural Area. This basalt lava flowed over northern Oregon and southwest Washington between 14 and 17 million years ago (City of Portland, 2009). The upper part of the state natural area is composed of an older section of basalts and sedimentary rocks titled the Basalts of Waverly Heights aging back 35 to 55 million years. More recently (about 1 million years ago), the Boring Lavas covered the CRBG in the western portion of the watershed with a basaltic and andesitic composition, originating from Mt. Sylvania (Williams & Coulton, 1997). The Boring lavas are characterized by a locally perched water table. Fine-grained sediments from the Missoula Floods can be found in the Multnomah and Capitol Hill area. The basaltic bedrock is more compacted and not eroded as much as sedimentary rocks, leading to less sediment sources within the creek where basalt is dominant. Figure 6.1 shows a section of exposed basalt bedrock in Marshall Park. This portion of the creek is characterized by steep slopes that cause transport of sediment and erosion, leading to exposure of the underlying bedrock. The basalt-sourced sediment can be characterized as angular in shape, causing it to have more potential for sediments to settle in cavities among the rocks (Herrera Environmental Consultants, 2009). An angular characteristic is also a sign of less erosion and therefore indicative that flow velocity is lower through those reaches.

Figure 6.1 Image of the exposed bedrock of Tryon Creek within Marshall Park (Source: Barton, A.)

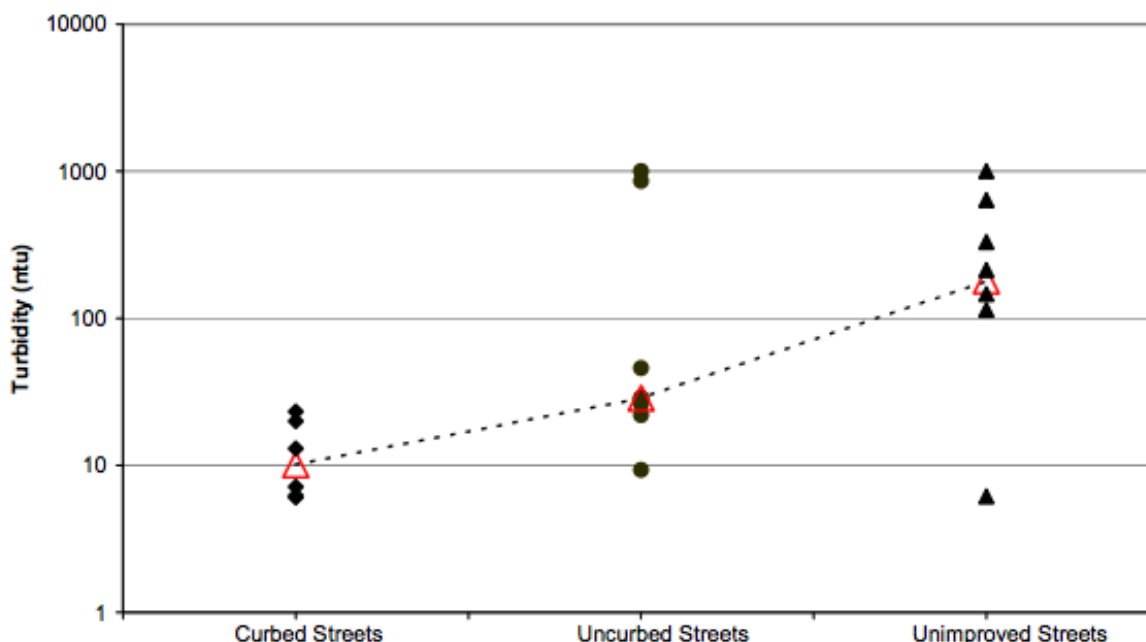
Finally, this research assessed the sources of fine sediments in Fanno and Tryon Creeks. Turbidity measurements of stormwater from curbed, uncurbed, and unimproved streets suggest that turbidity decreases as road infrastructure improves. Turbidity at curbed streets was the lowest and least variable with a mean value of 10 NTUs (Figure 6.4). Turbidity values were more varied at uncurbed and unimproved streets, causing researchers to display the median value of 28 NTUs for uncurbed and 180 NTUs for unimproved streets.

Figure 6.4 Turbidity measurements at each of the sampled locations with the median values indicated using red triangles (Source: City of Portland).

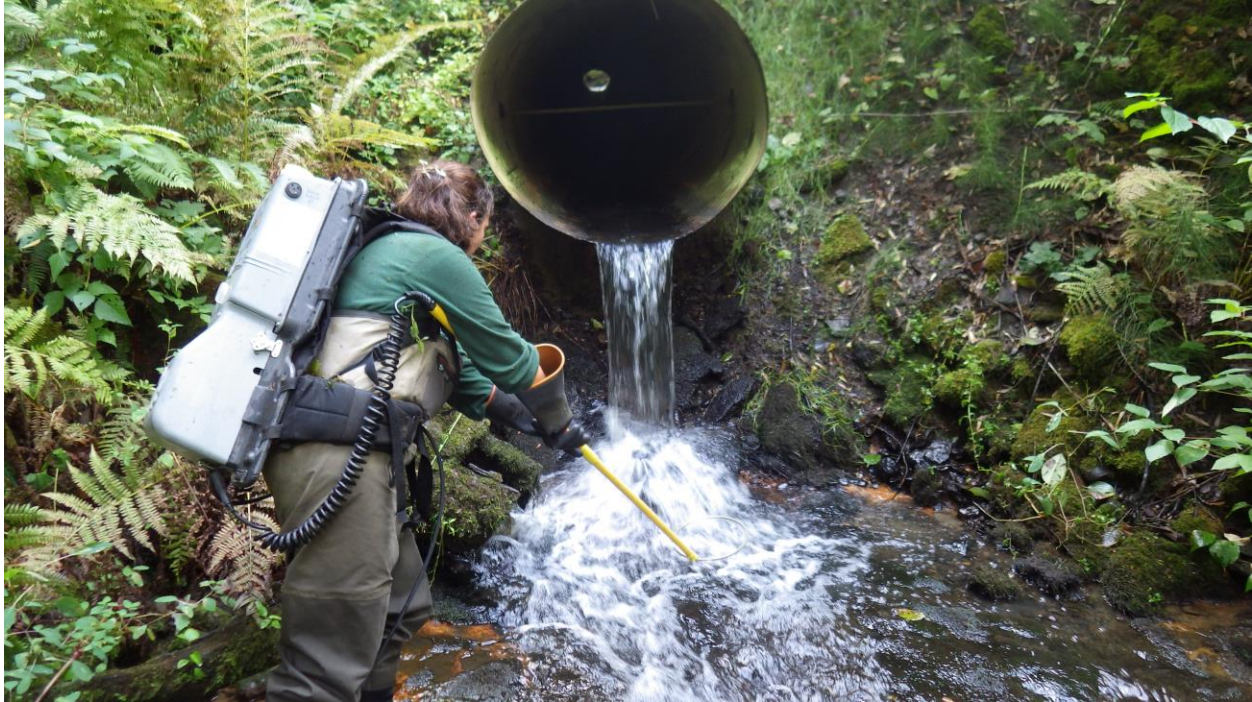
Figure 7.1 United States Fish and Wildlife Service (USFWS) scientist surveys for fish below the Atwater Rd culvert to interpret the impacts of culverts on the native fish population (Source: United States Fish and Wildlife Service).

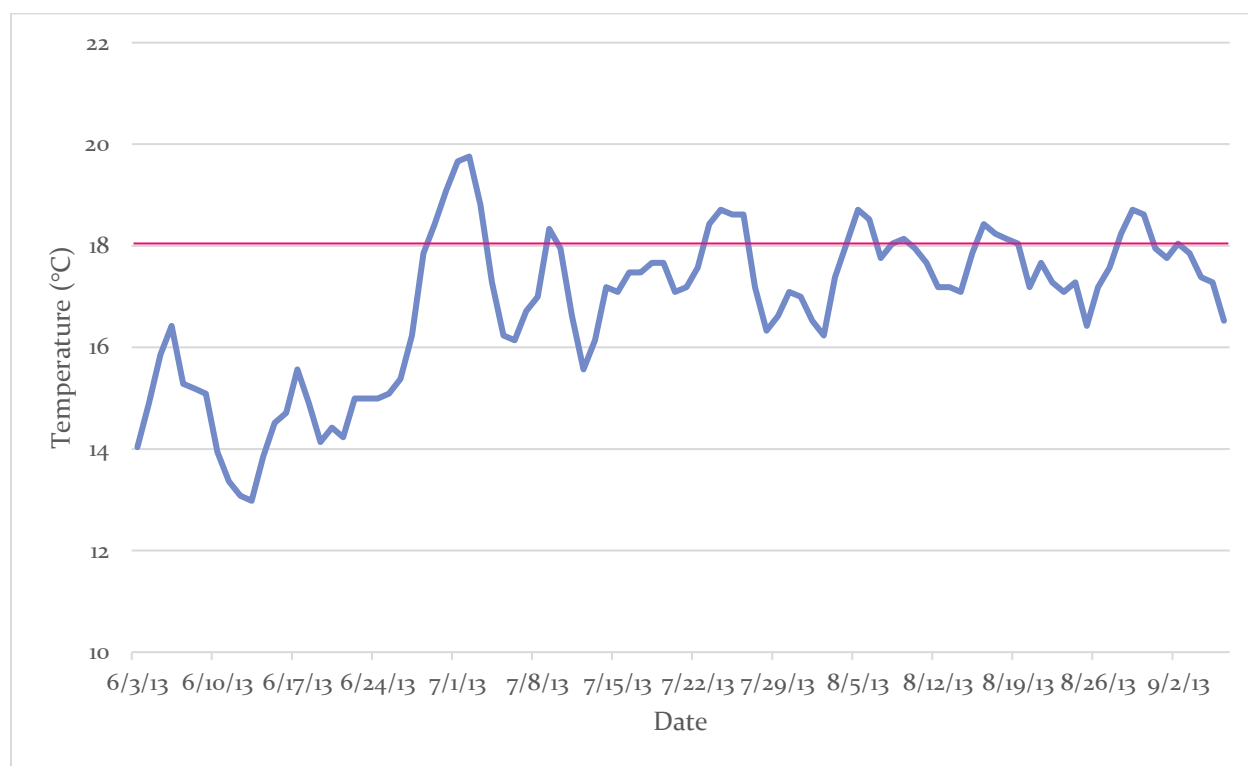
During summer field studies in 2013, the USFWS collected temperature using a logger at Nettle Creek. Figure 8.2 displays the hourly temperature readings recorded at Nettle Creek from June 3 to September 2, 2013. This is not during the spawning months, so the 7-day average maximum is 18°C (marked with a red horizontal line), which is met or exceeded on 22 of the 96 days.

Figure 8.2 Hourly temperature readings during the summer of 2013 (Source: United States Fish and Wildlife Service).

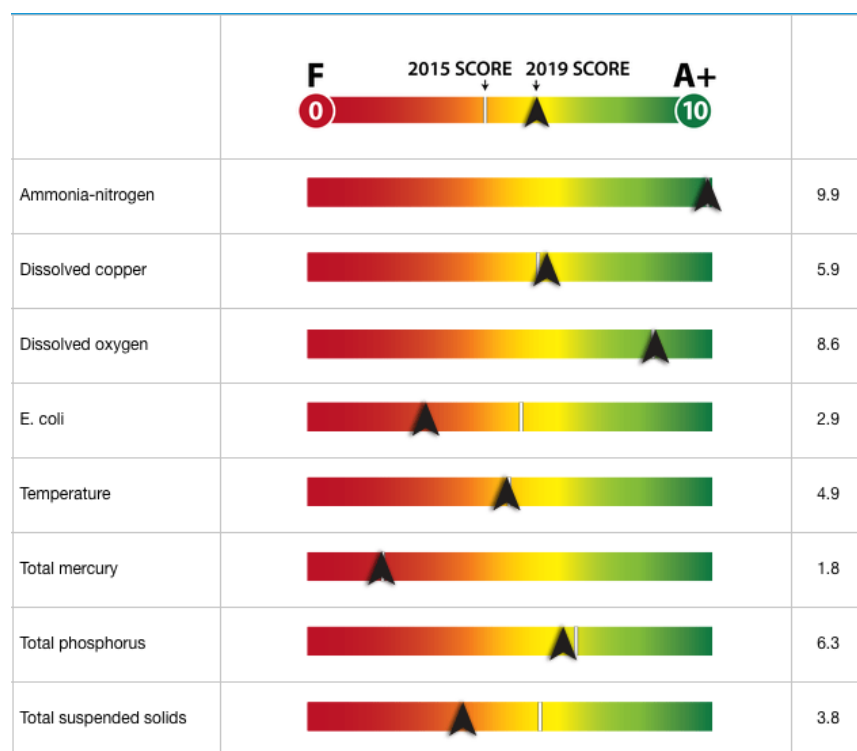
Figure 8.3 each of the water quality parameters and the corresponding scores that combined to create the water quality report card rating (Source: City of Portland).

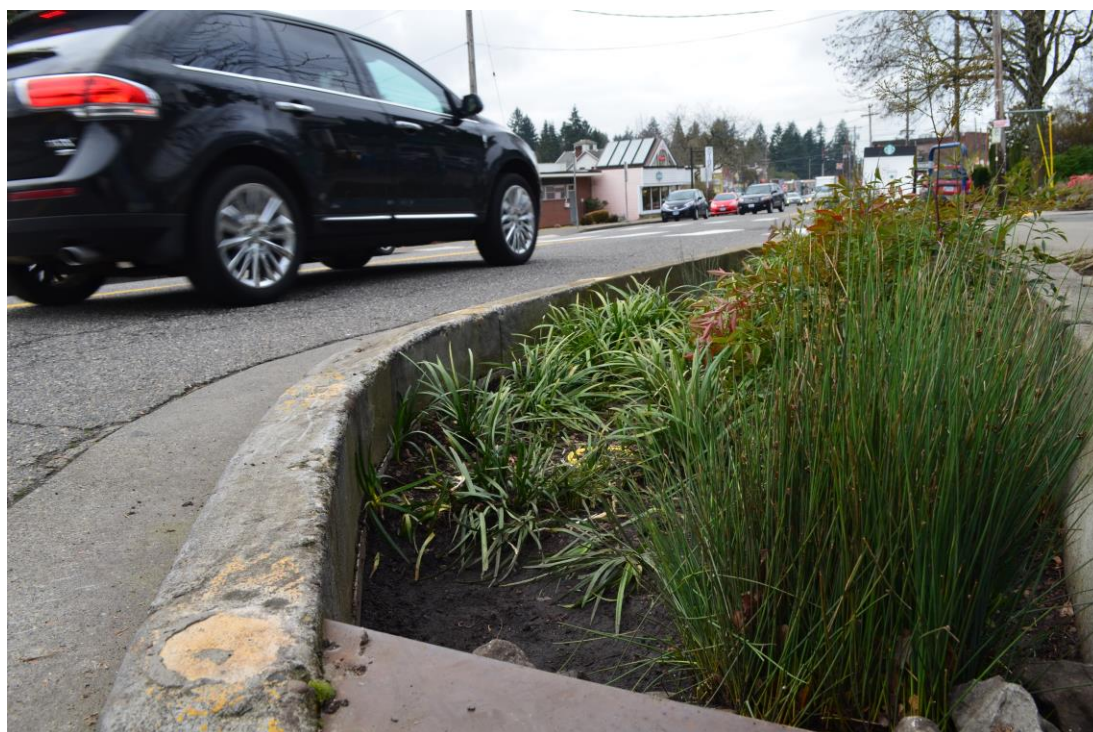
Figure 10.2 Bio-swales with low maintenance native vegetation improve roadside aesthetic while providing water storage and filtration services (Source: Barton, A.).
